# CaseStudy

## BFM® fitting Connecting Sleeve

### Preventing lost production

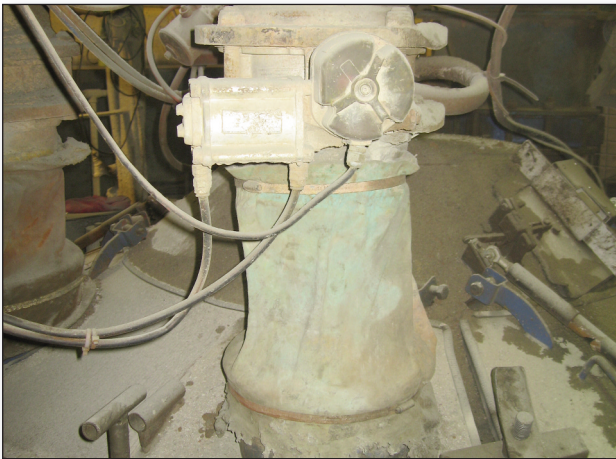
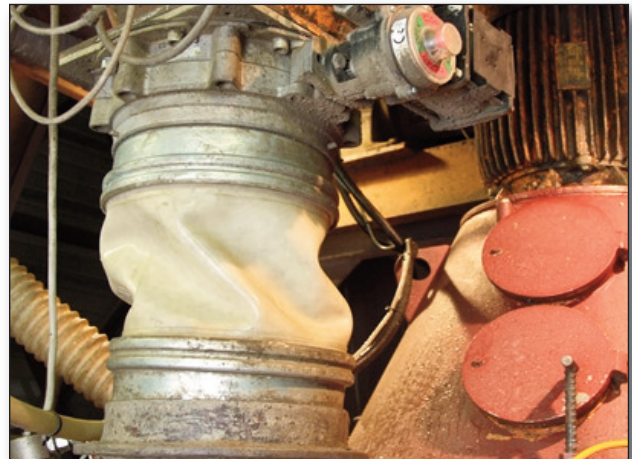
**The Challenge:** Canvas weigh hopper connectors at a leading concrete products manufacturer absorbed moisture, making them prone to blockage causing lost productivity and poor weighing accuracy. To add to the problem, jubilee clips caused excessive dust leakage and made replacement extremely time consuming.

**Our Solution:** BFM® fitting

**Key Features:** Sleeve snaps into place for perfect seal. No more clips.

**Improvement:** Blockages eliminated  
Changing time reduced from 20 minutes to 1 minute
